Appendix: Inficon Communication Lost After Windows 7 (Optional) Updates Have Been Installed - Reassigning Communication Ports Procedure

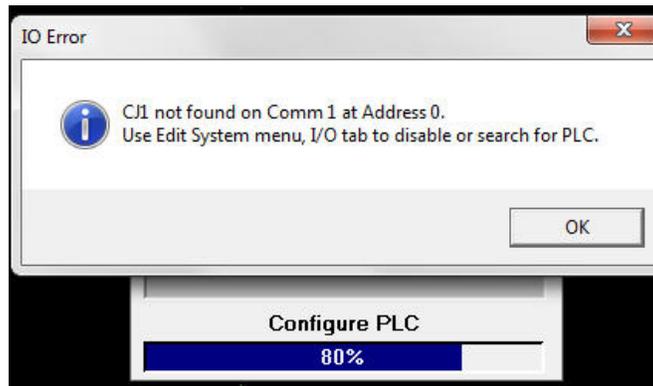
Follow this procedure if installing a Windows 7 (optional) update has reassigned the system PC serial port numbers causing the communication issue shown below on the start up of Inficon indicating the software cannot communicate with the PLC.

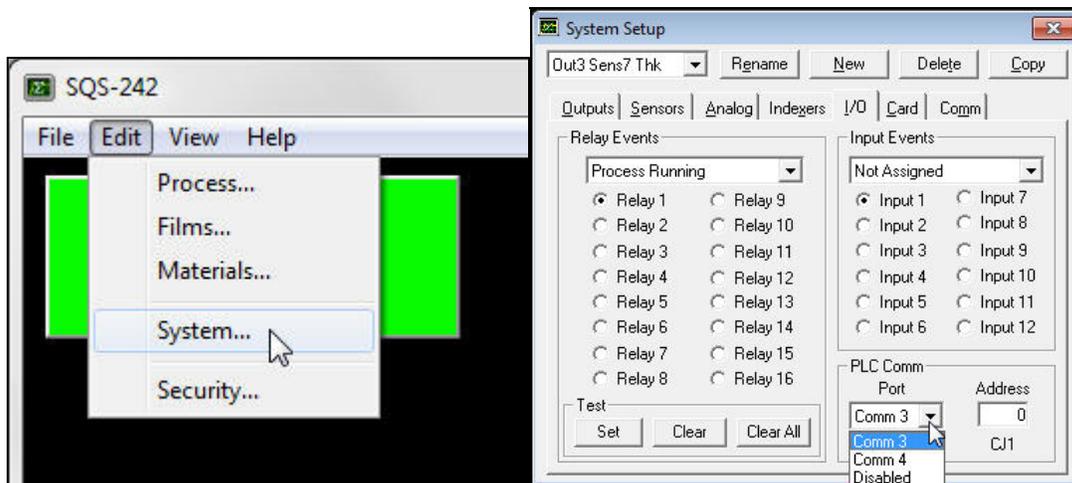
Verify in the System Setup, I/O tab that Comm 1 is unavailable then close the Inficon software.

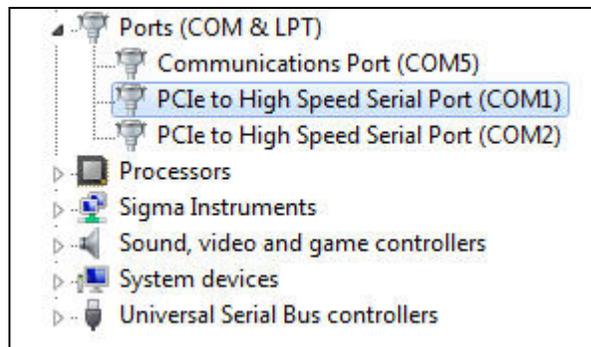
Correct port assignments.
